# **UPPER TRINITY RIVER WATERSHED ASSESSMENT REPORT & MANAGEMENT AND ACTION PLAN**

**Prepared by:  
Trinity County Resource Conservation District  
March, 2006**

**Grant Funding Provided By:  
State Water Resources Control Board**

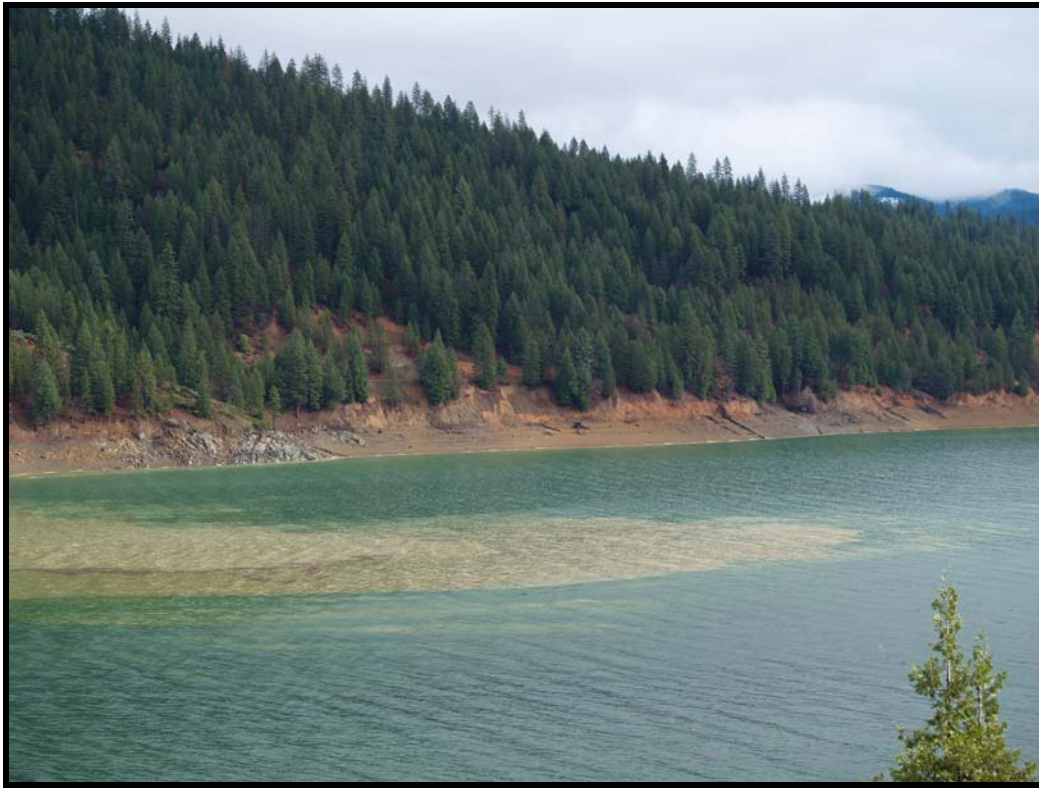
Photo 1-1 Sediment plume entering Trinity Lake near Trinity River inlet in December 2005.

In heavy rainfall years, large volumes of fine sediment are eroded from the watershed upstream of Trinity Dam and subsequently trapped and suspended in Trinity Lake many months after these events occur. The degree of the problem has been immediately reflected in the visually high turbidity levels of the water that is subsequently released from the Dam into the Trinity River or exported over the Trinity Divide and into Whiskeytown Lake and ultimately, the Sacramento River and the Bay-Delta system. Turbidity readings in Trinity Lake reached their highest levels in twenty-two years after the storms events of 1997 and remained relatively high through most of 1998. The obvious correlation between these rainfall events and the resulting high turbidity may be indicative of serious erosion and sediment problems that exist within the Watershed. In addition to the water quality reduction caused by high turbidity levels, the buildup of sediment in the lake has the potential to reduce available storage capacity and ultimately threaten the life expectancy of the dam. Photo No. 1-1 was taken during a rainfall event in December of 2005 and is indicative of the sediment plumes that are frequently seen at the north end of the lake.

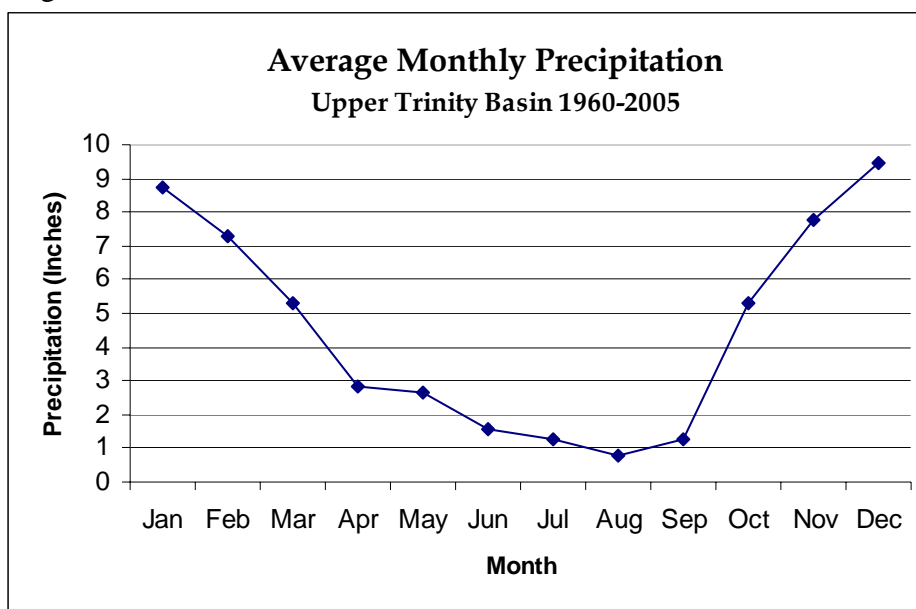
Figure 2-3

Source: California Data Exchange Center, Coffee Creek RS, 4400' elevation, operated by USFS

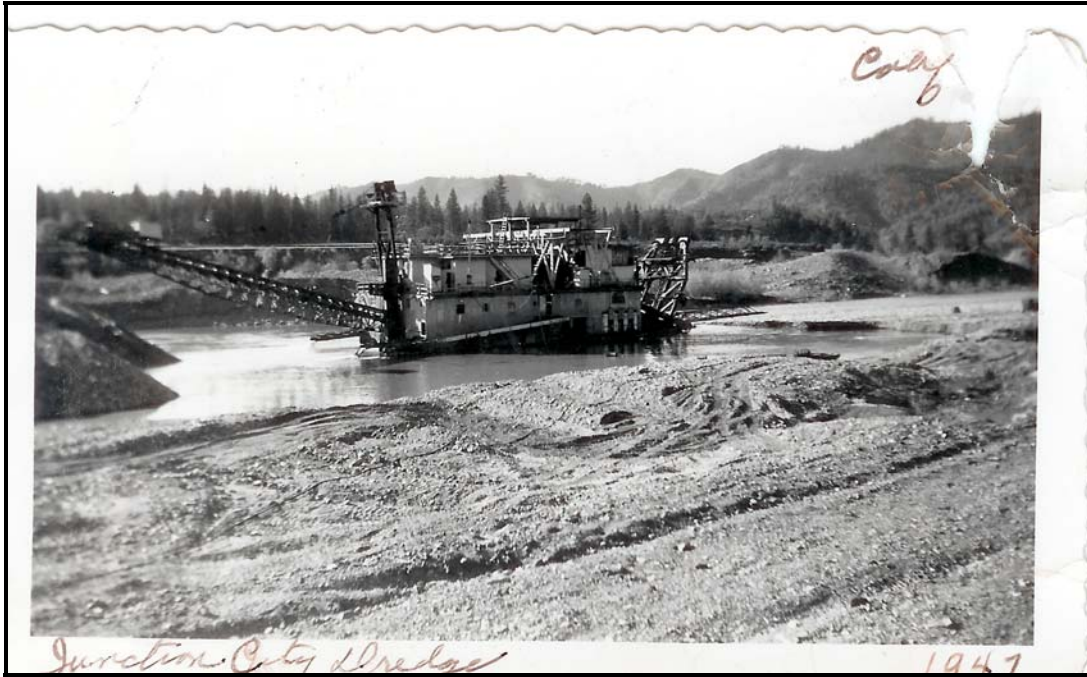
Photo 3-1 Typical bucket line dredge used along the upper Trinity River leaving piles of dredge tailings. This photo was taken in 1947 in Junction City.

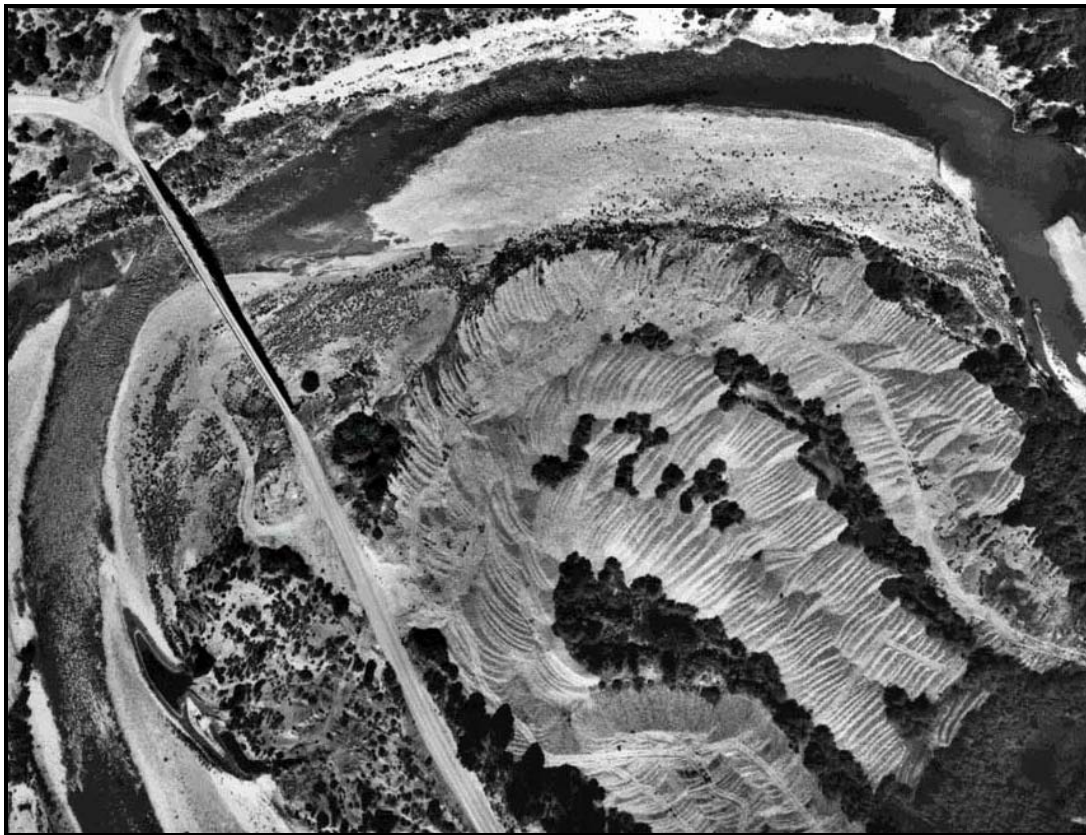
Photo 3-2 Example of rock tailings showing amount of alluvium moved by dredgers.  
Photo taken near Junction City in 1961

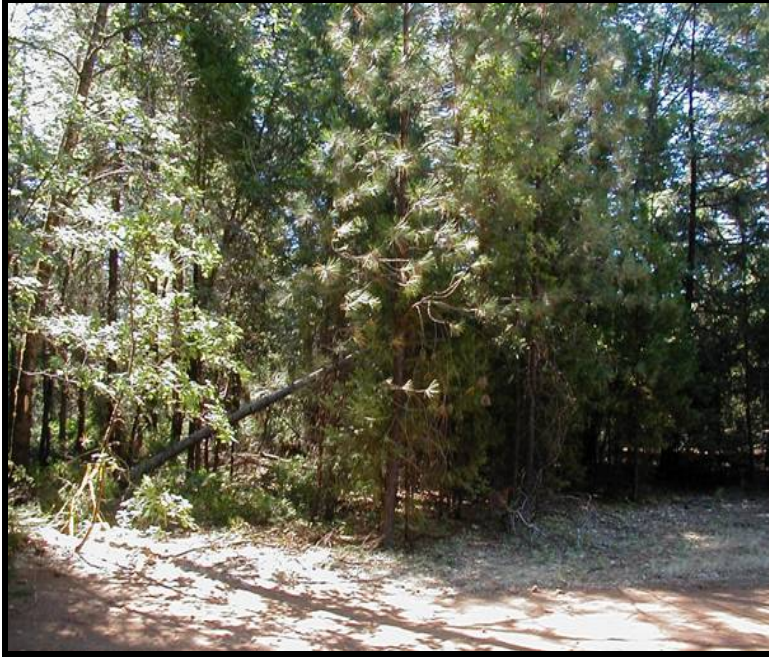
Photo 4-2 Area before treatment.

Before and after photos showing fuels reduction work near the Trinity Center Ball Park adjacent to Wyntoon Resort. Work consists of removing the “ladder fuels”, or the brush and thick undergrowth that quickly moves the fire from the ground to the trees. This fuels project was completed by the Trinity County RCD in 2004.

The intent of the fuels reduction projects is to reduce the chance of fire starts in the Wildland Urban Interface areas located next to residential communities. The reduction in fuels also give firefighters a chance to control wildfires and reduces the intensity of fire, thereby limiting the damage to soils which could lead to increased soil erosion and delivery of sediment to streams.

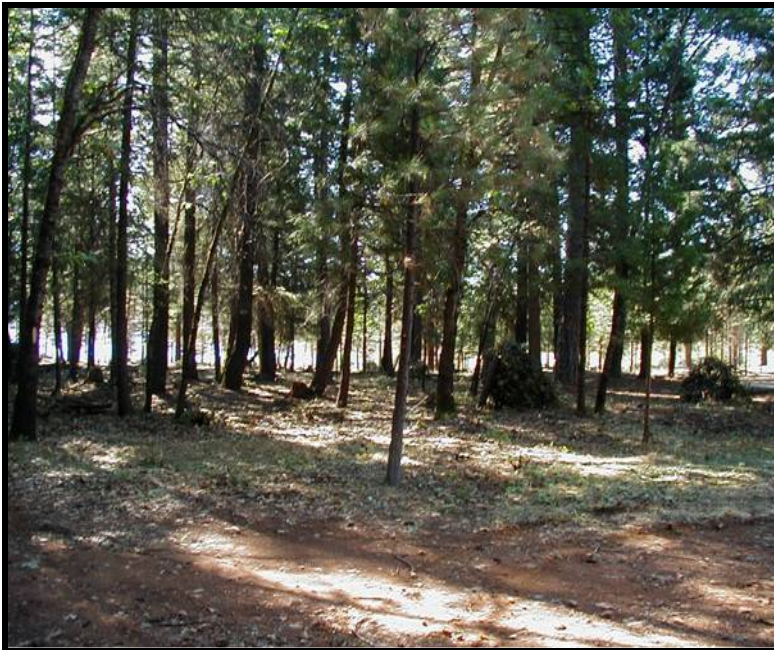
Photo 4-3 Area after treatment

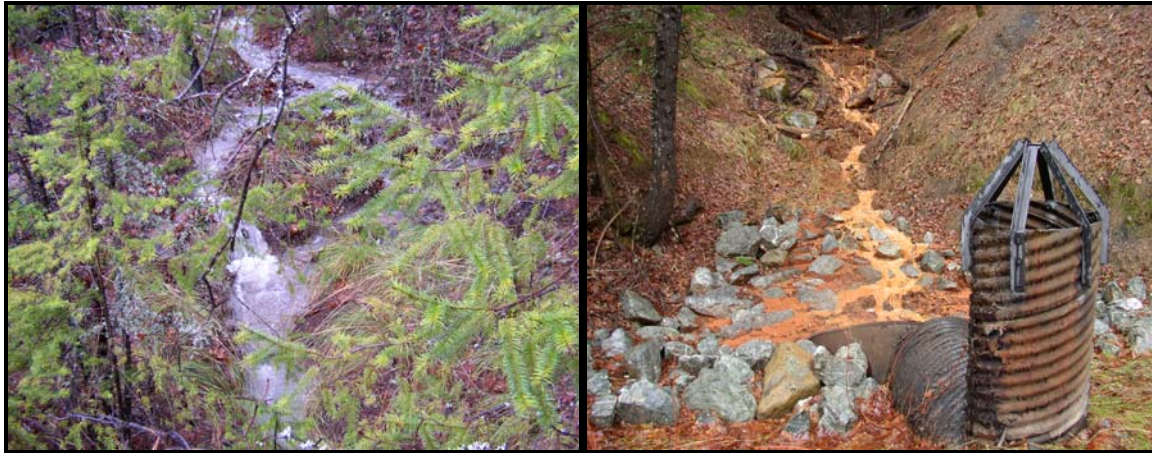
Photo 5-1 Inlet of culvert at mile marker 62.13 and 61.81

The turbidity of the water at the inlet and outlet of these two creeks vary remarkably even though they are only 563 yards apart. In cases like these, investigations should be conducted to see if the cause of sedimentation is natural or activity related and remedial actions should be initiated to reduce or prevent further occurrences. The creek on the left is at mile marker 62.13 and the one on the right is at mile marker 61.81 on Highway 3 North, and both outlets discharge directly into Trinity Lake.

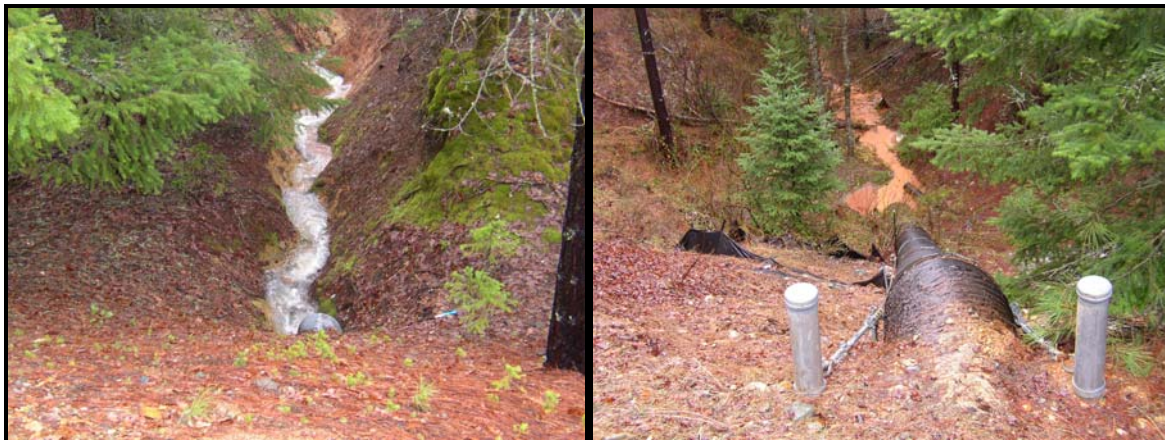
Photo 5-2 Outlets of culvert at mile marker 62.13 and 61.81 showing difference in turbidity levels.

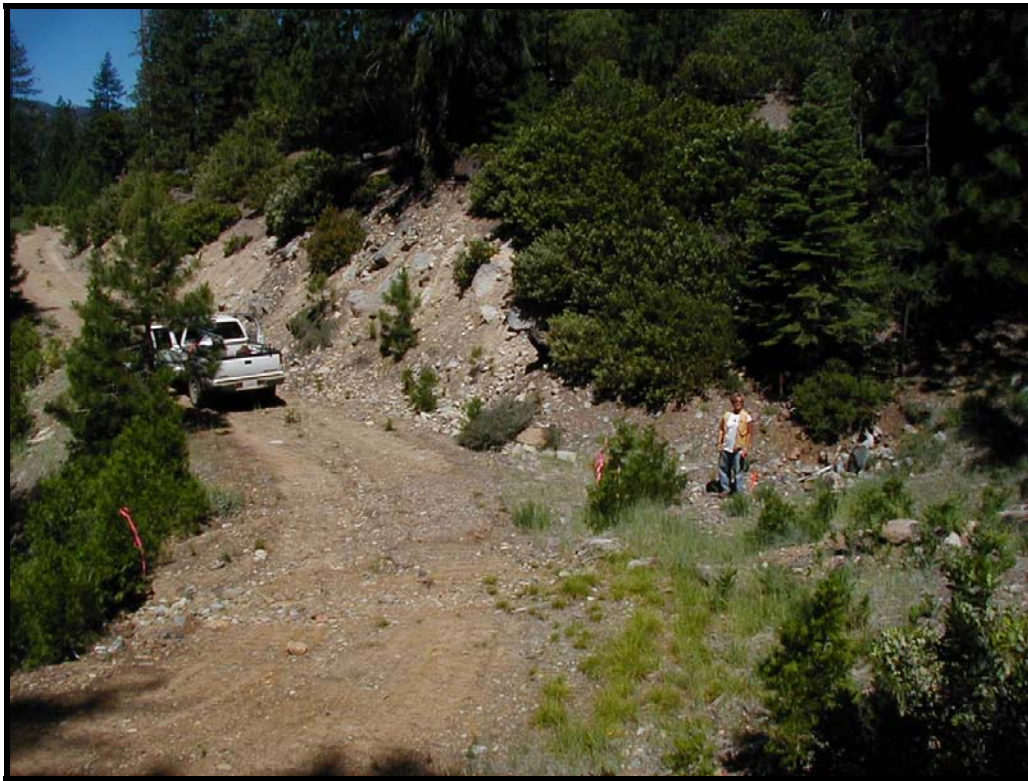
Photo 5-3. View of culvert with sediment filled inlet basin. Water has been flowing across road and downcutting road fill. Lack of minor maintenance could lead to crossing failure.

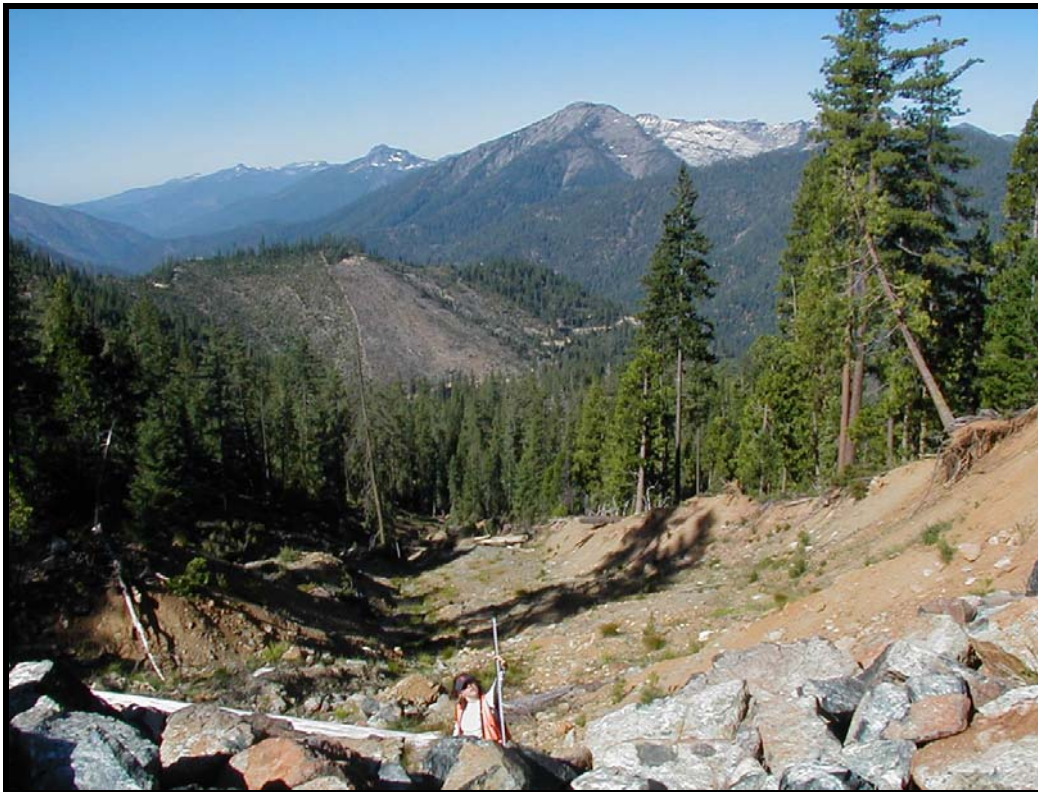
Photo 5-4 Measuring fill slope at culvert outlet. Riprap in foreground was placed to re-enforce road after landslide (mid-photo) event.
