Upper Trinity River Sediment Source Analysis

Prepared for:
Trinity County Resource Conservation District
P.O. Box 1450
Weaverville, CA 96093

Prepared by:
James Fitzgerald, PG (#8082)
Graham Matthews and Associates
P.O. Box 1516
Weaverville, CA 96093
February 2006

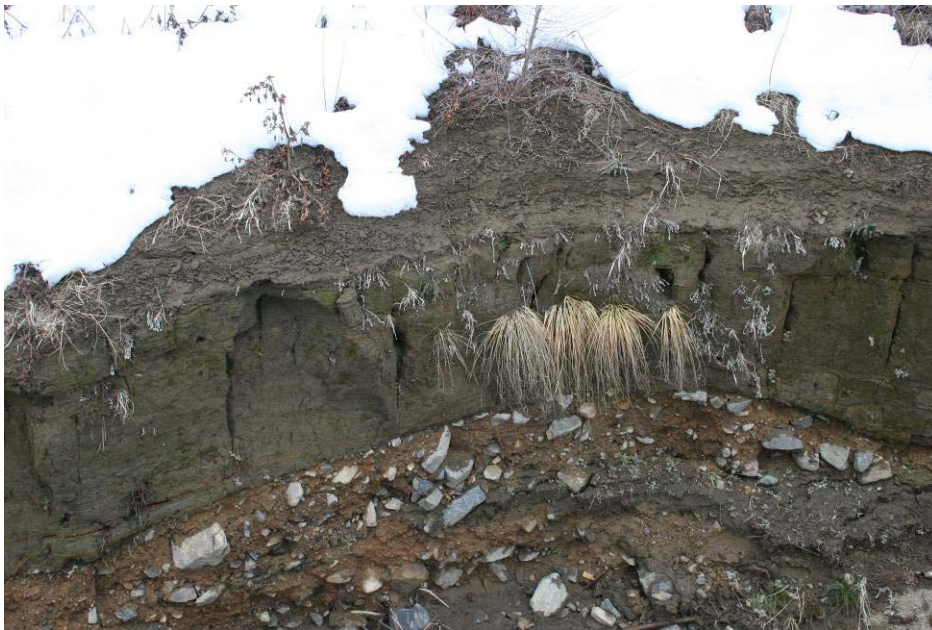
Figure 2.3.1. Example of delta sediment deposit surveyed to estimate the background sediment delivery rate.

In the field, points were surveyed in a rough grid fashion with an average approximate point density 20 ft apart, although actual point locations are chosen by topographic breaks rather than a set distance apart. The more topographically complex a section of ground or stream channel, the more points were required to accurately document topography. In many areas, the topography was quite complex due to depositional features (Figure 2.3.1).

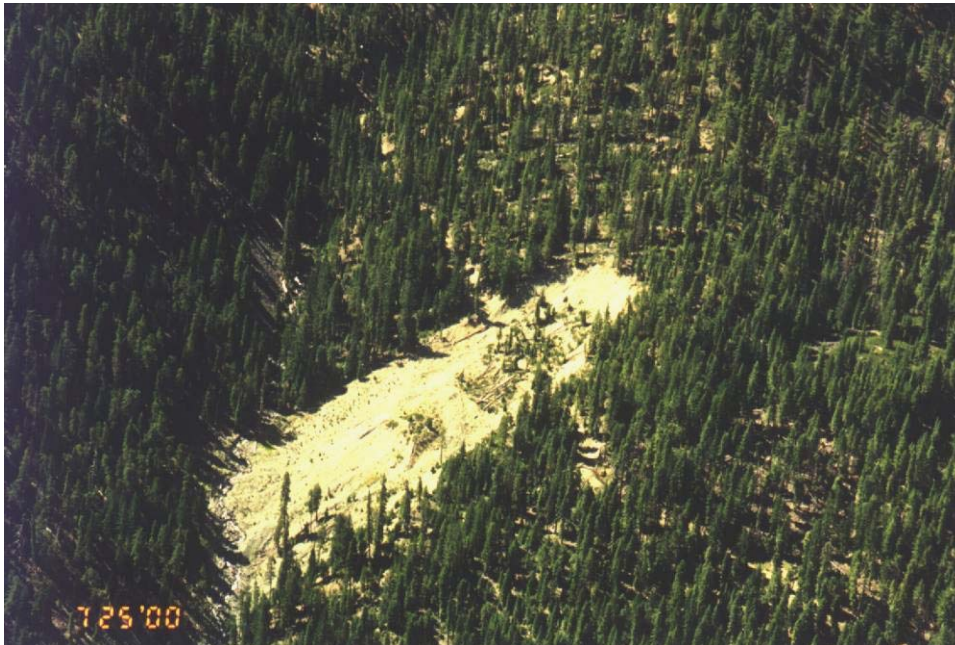
Figure 2.4.1. Example of debris slide with high sediment delivery.

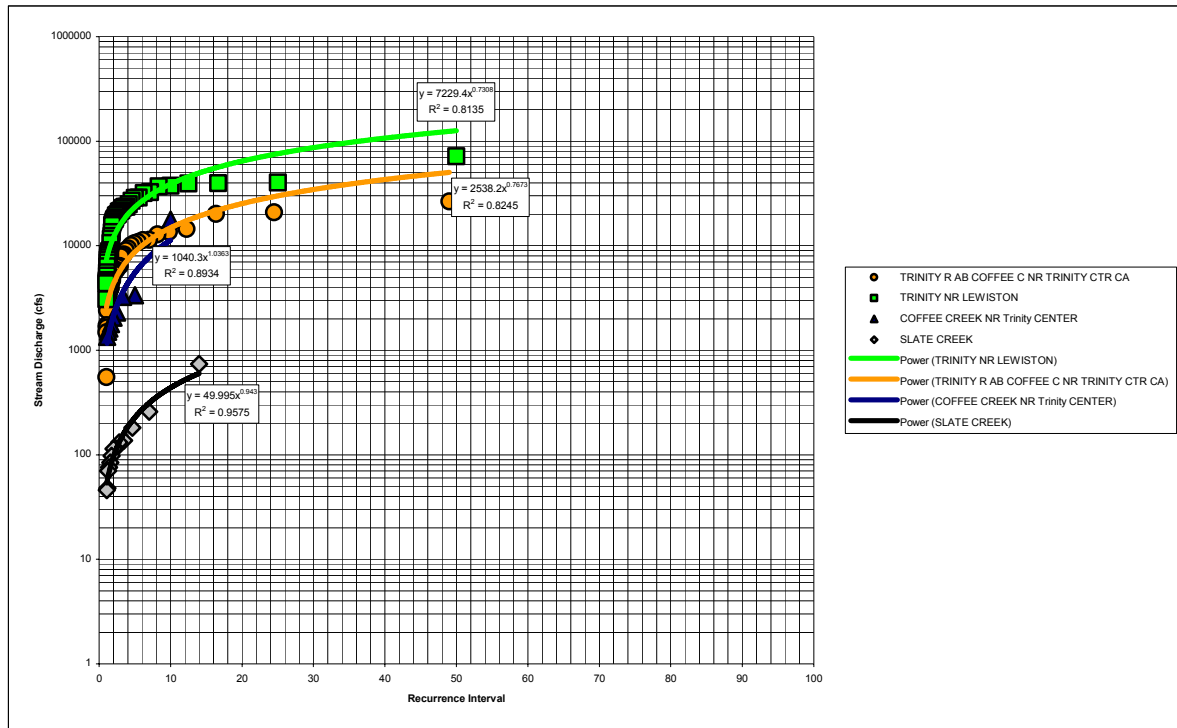
Figure 3.1.1. Graphical flood frequency for Upper Trinity continuous streamflow gages.

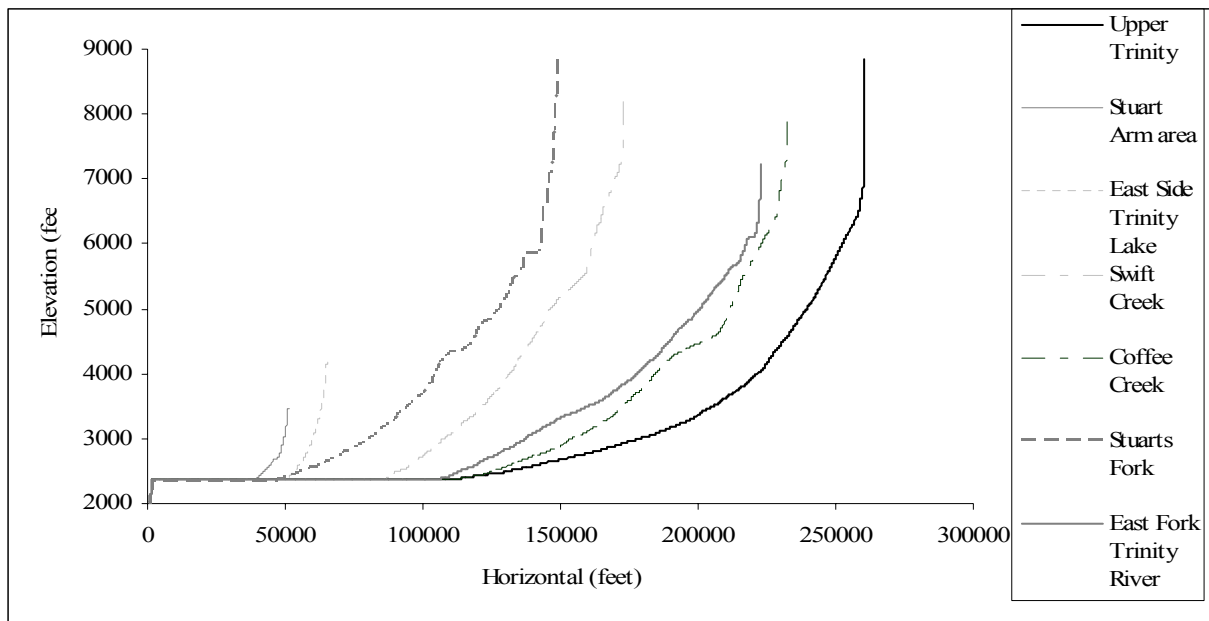
Figure 3.2.1. Graph showing selected subwatershed longitudinal profiles, all horizontal distances start from the Trinity Lake dam. Vertical exaggeration is about 2:1.

Glacial deposits are found in the northern part of the watershed including Stuarts Fork, Swift Creek, and Coffee Creek valleys. Alpine glaciation shaped the headwaters of the UT and benches visible in Figure 3.2.1. In the lower portion of these subwatersheds, terraces composed of sand and gravel from glacial erosion flank much of the response channel types.

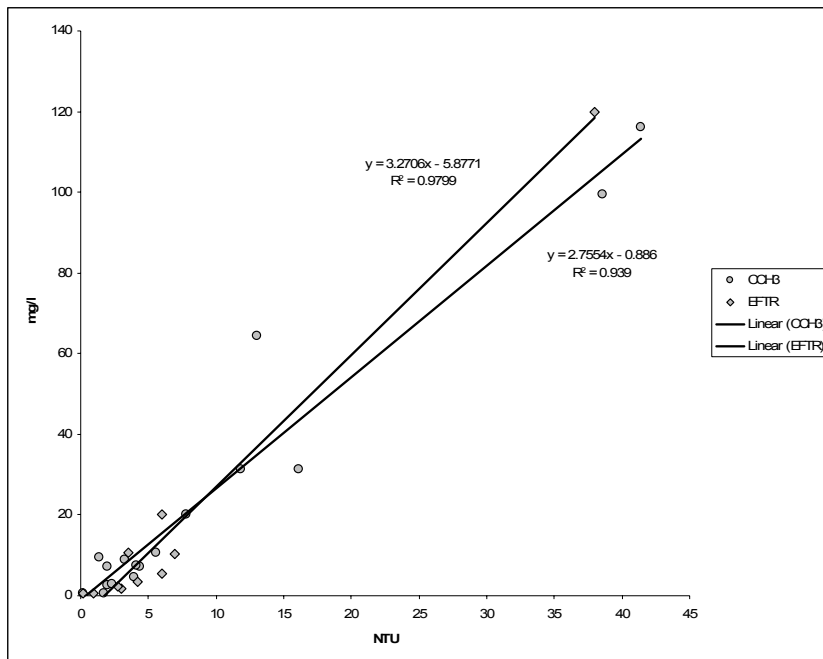
Figure 3.3.1. Suspended sediment versus turbidity rating curve for the East Fork Trinity River and Coffee Creek.

Streamflow and sediment transport data are used to help verify and understand sediment source analysis results. There is a significant relationship between suspended sediment concentration and turbidity and the East Fork Trinity River at Trinity County Road 106 (EFTR) and Coffee Creek at Highway 3 (CCH3) (Figure 3.3.1). This relationship shows that most of the elevated turbidity results from suspended sediment transported as wash load. The EFTR regression equation was used to predict the suspended sediment concentration for sampling events that only measured turbidity.

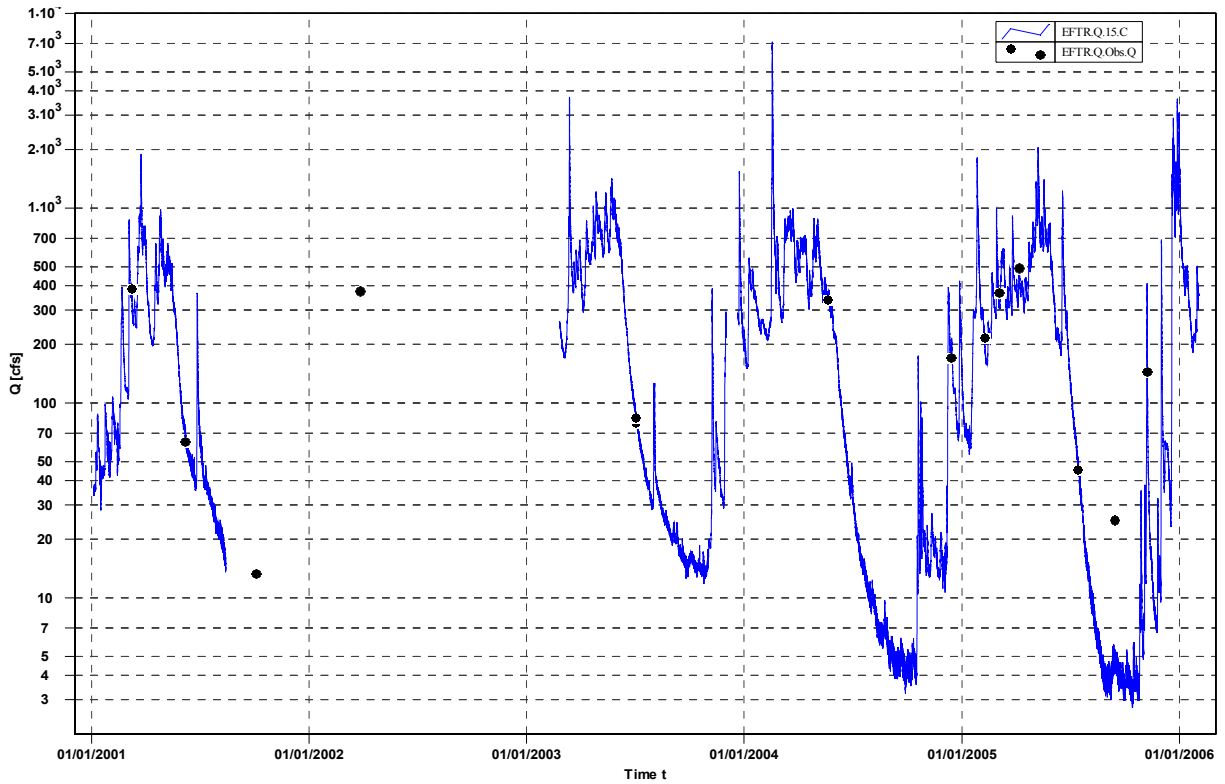
Figure 3.3.2. East Fork Trinity River hydrograph for water years 2000-2005.

According to the continuous streamflow records, for water years 2000 and 2005 the annual peak streamflows were about a Q₂ flood event. For water year 2000 the peak occurred in the spring as a result of snowmelt, whereas, for water year 2005 the peak occurred during the winter as a result of a rain-on-snow event (Figure 3.3.2).

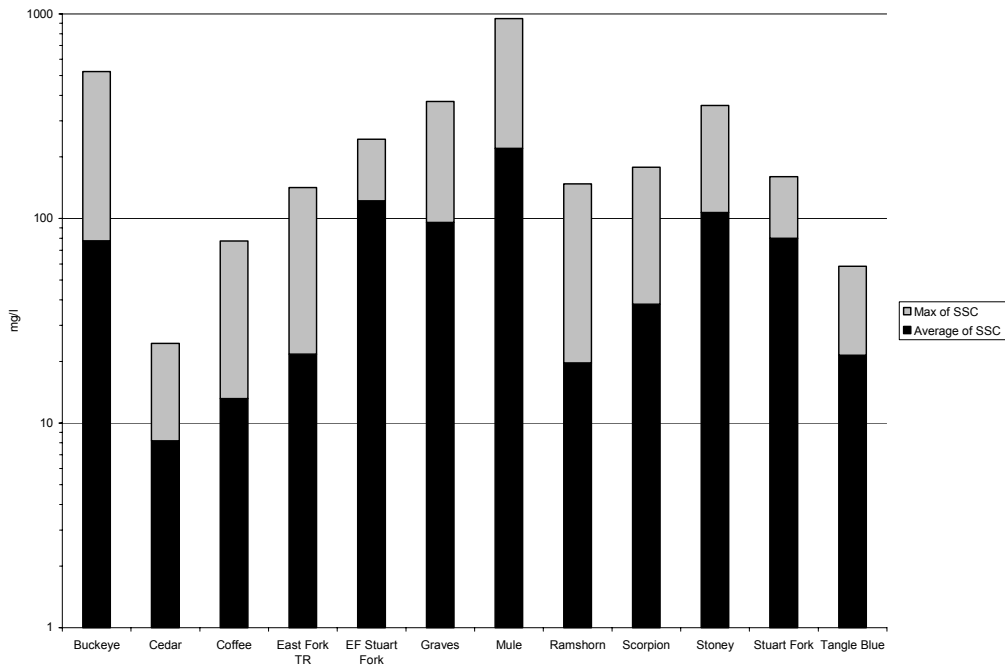
Figure 3.3.3. Water year 2005 average and maximum suspended sediment concentration by site.

Suspended sediment and turbidity samples were taken during water years 2000 and 2005. This analysis focuses on water year 2005 data because the peak streamflow resulted from a rain-on-snow event and represents present land form conditions (Figure 3.3.3).

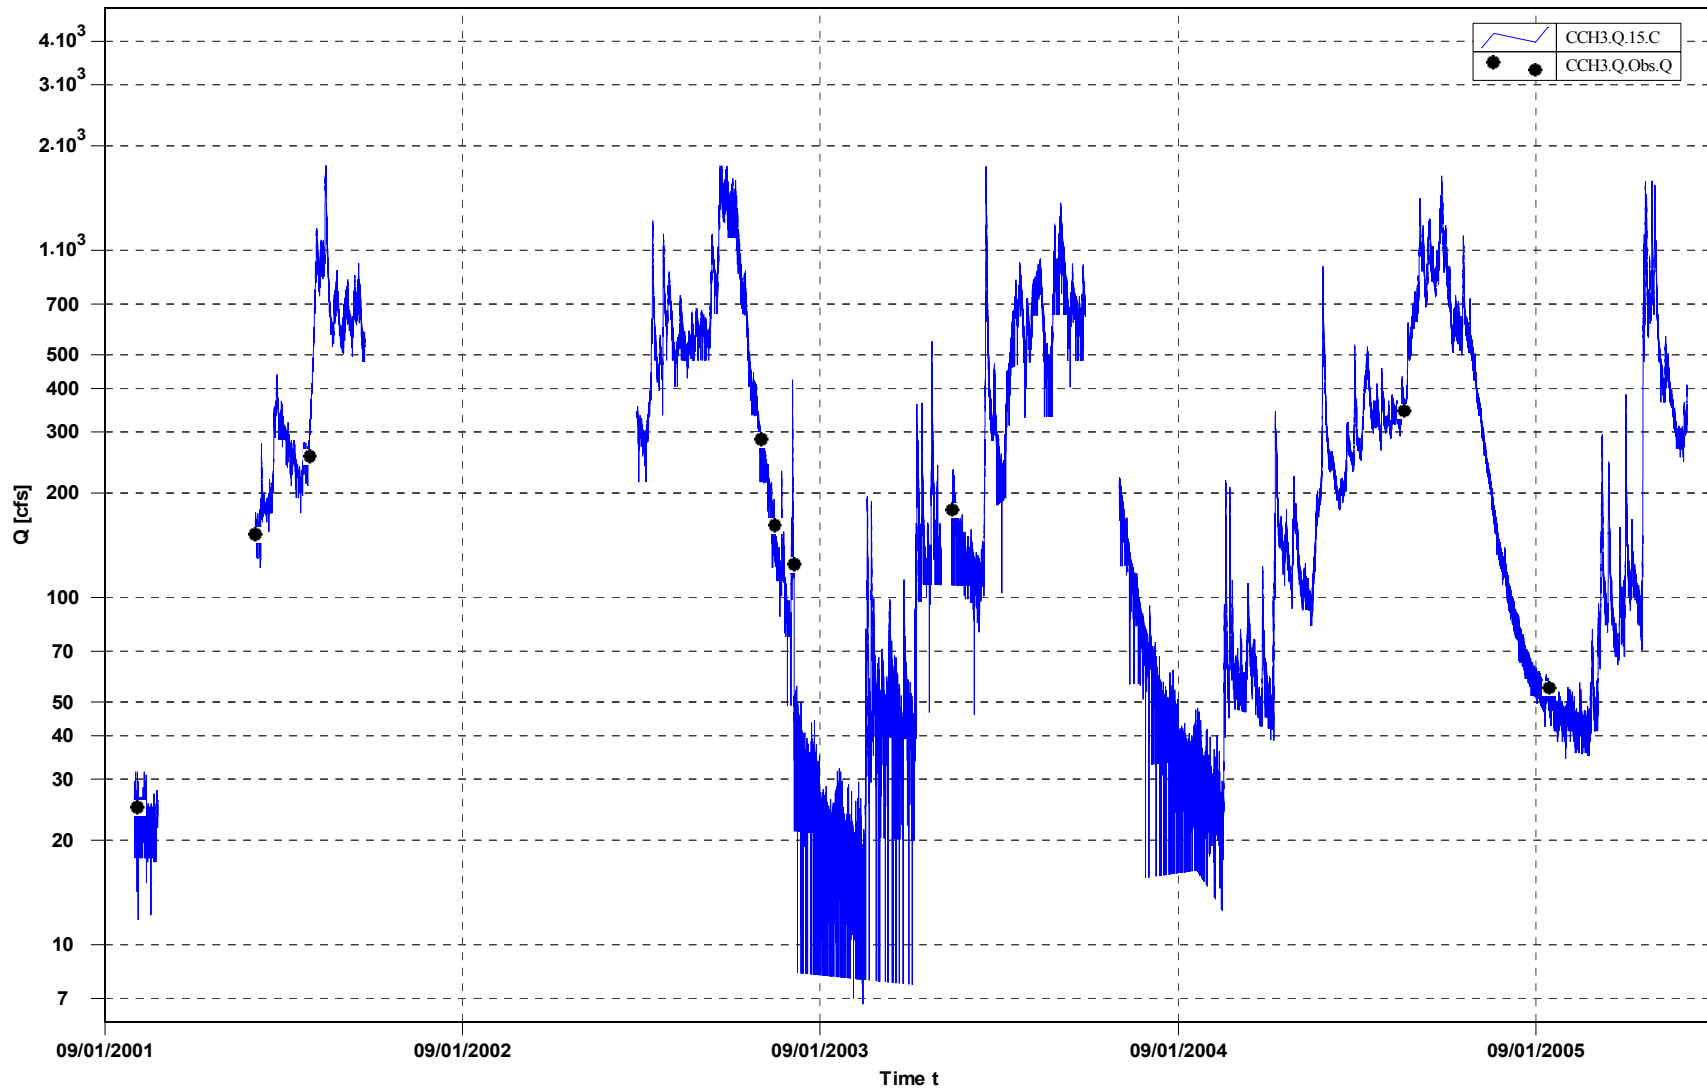
Figure 1. Coffee Creek at Highway 3 WY 2002-2005 hydrograph.

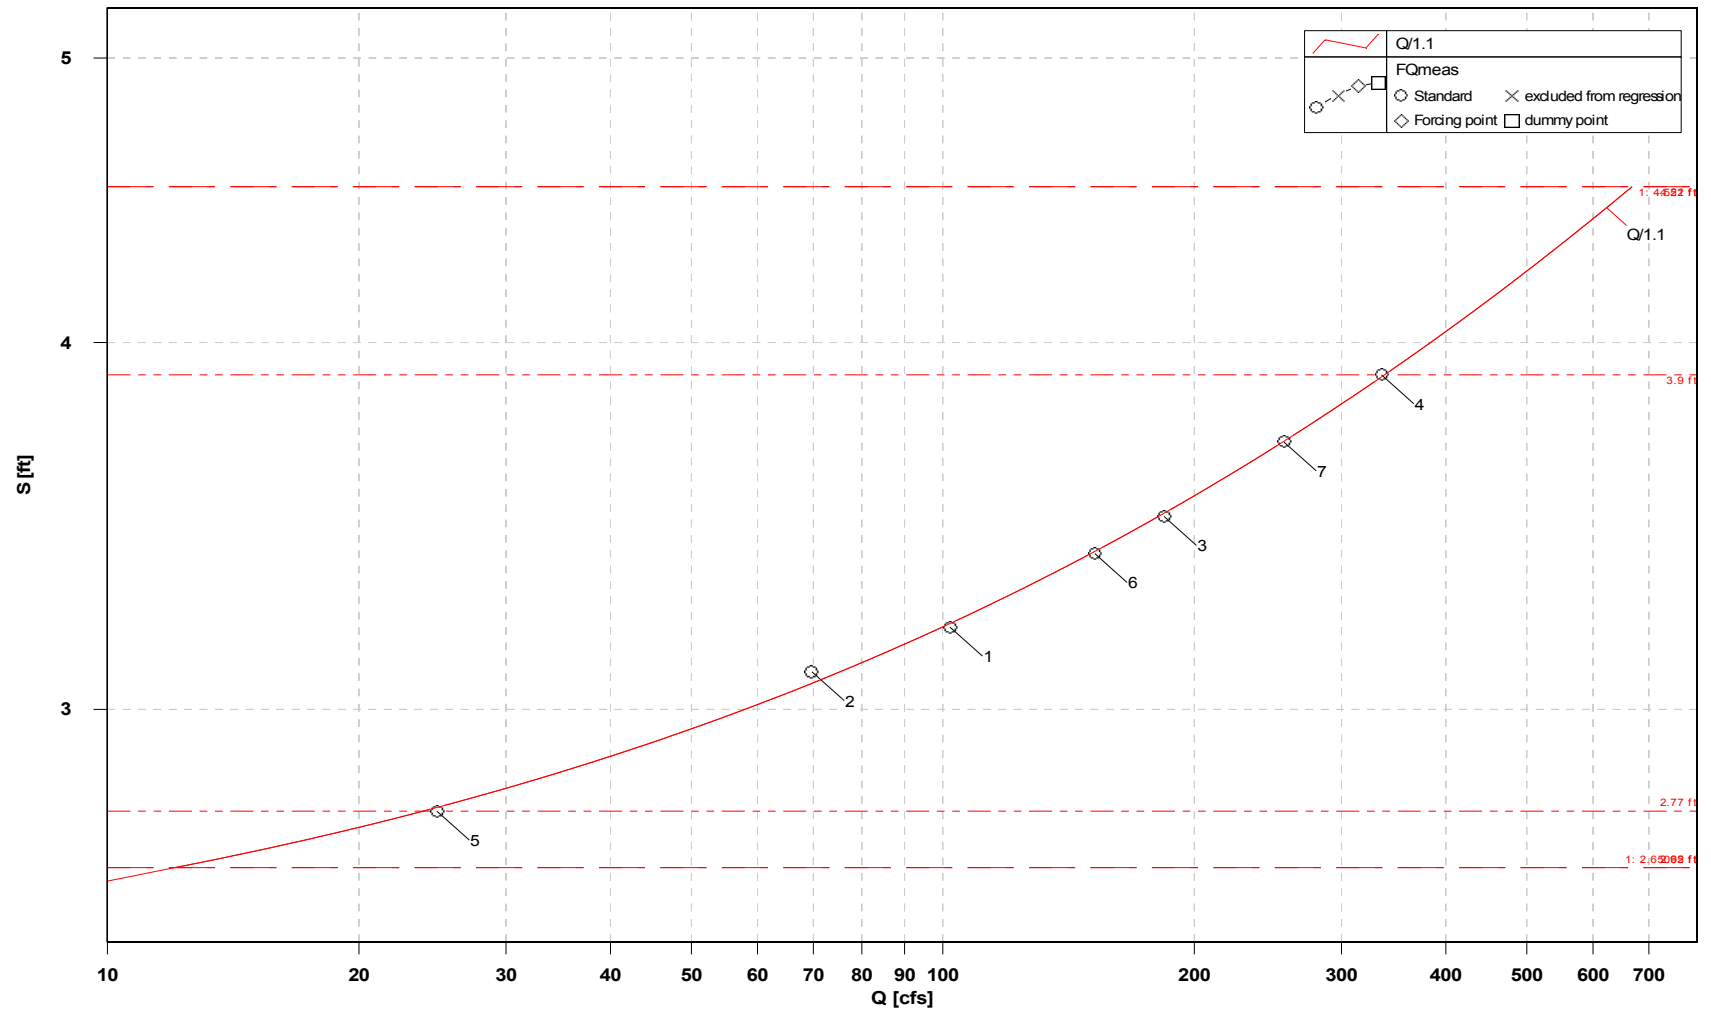
Figure 2. Coffee Creek at Highway 3 streamflow rating curve.

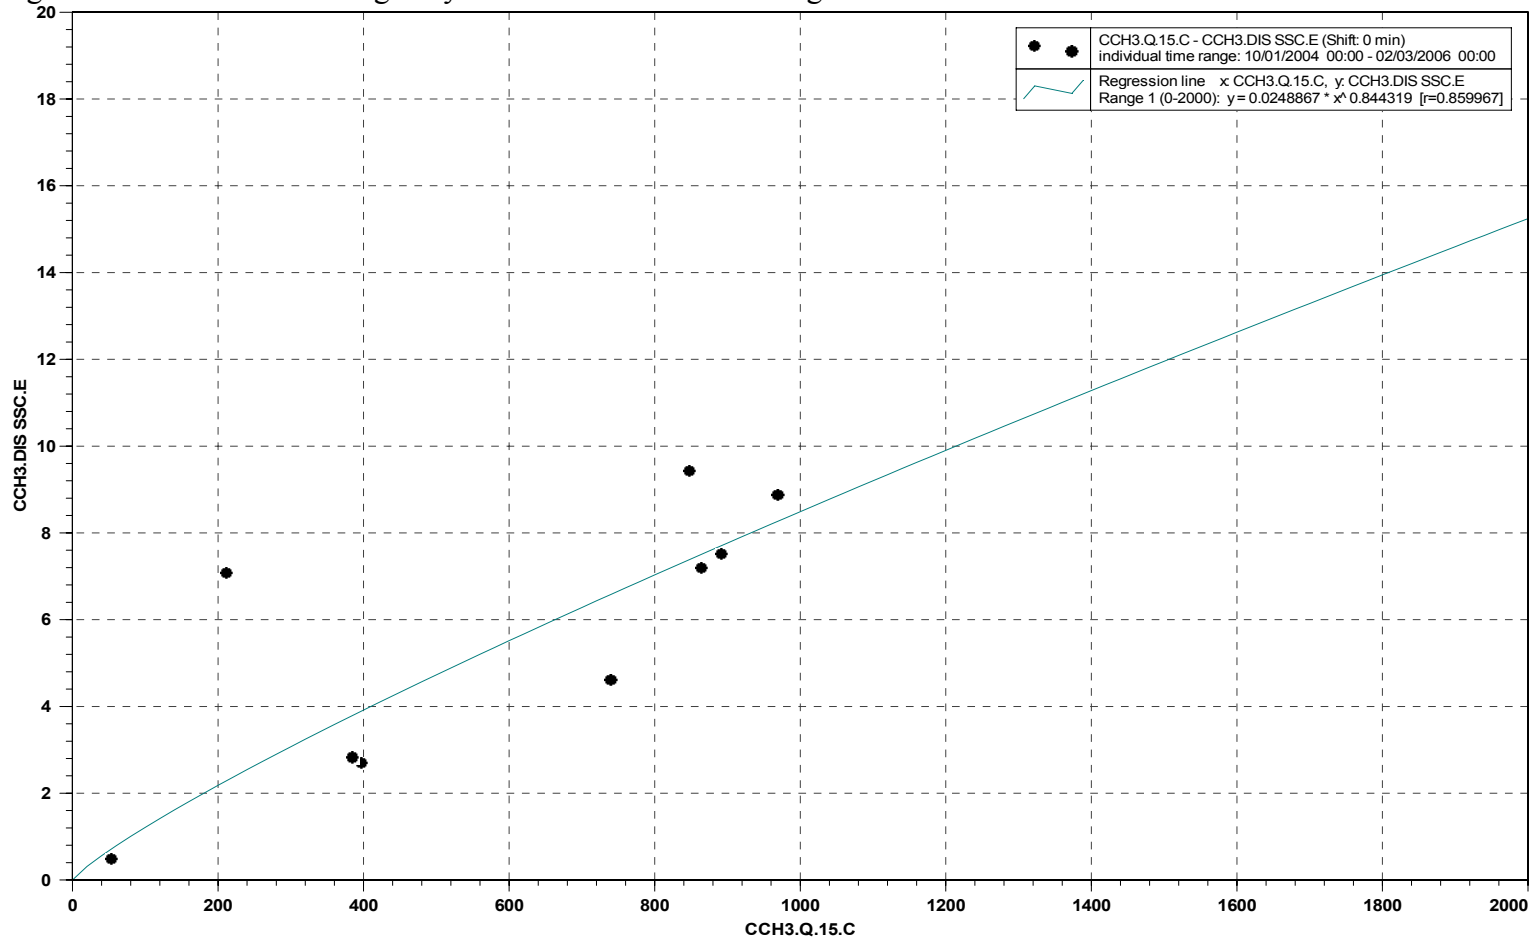
Figure 3. Coffee Creek at Highway 3 WY 2005 sediment rating curve.

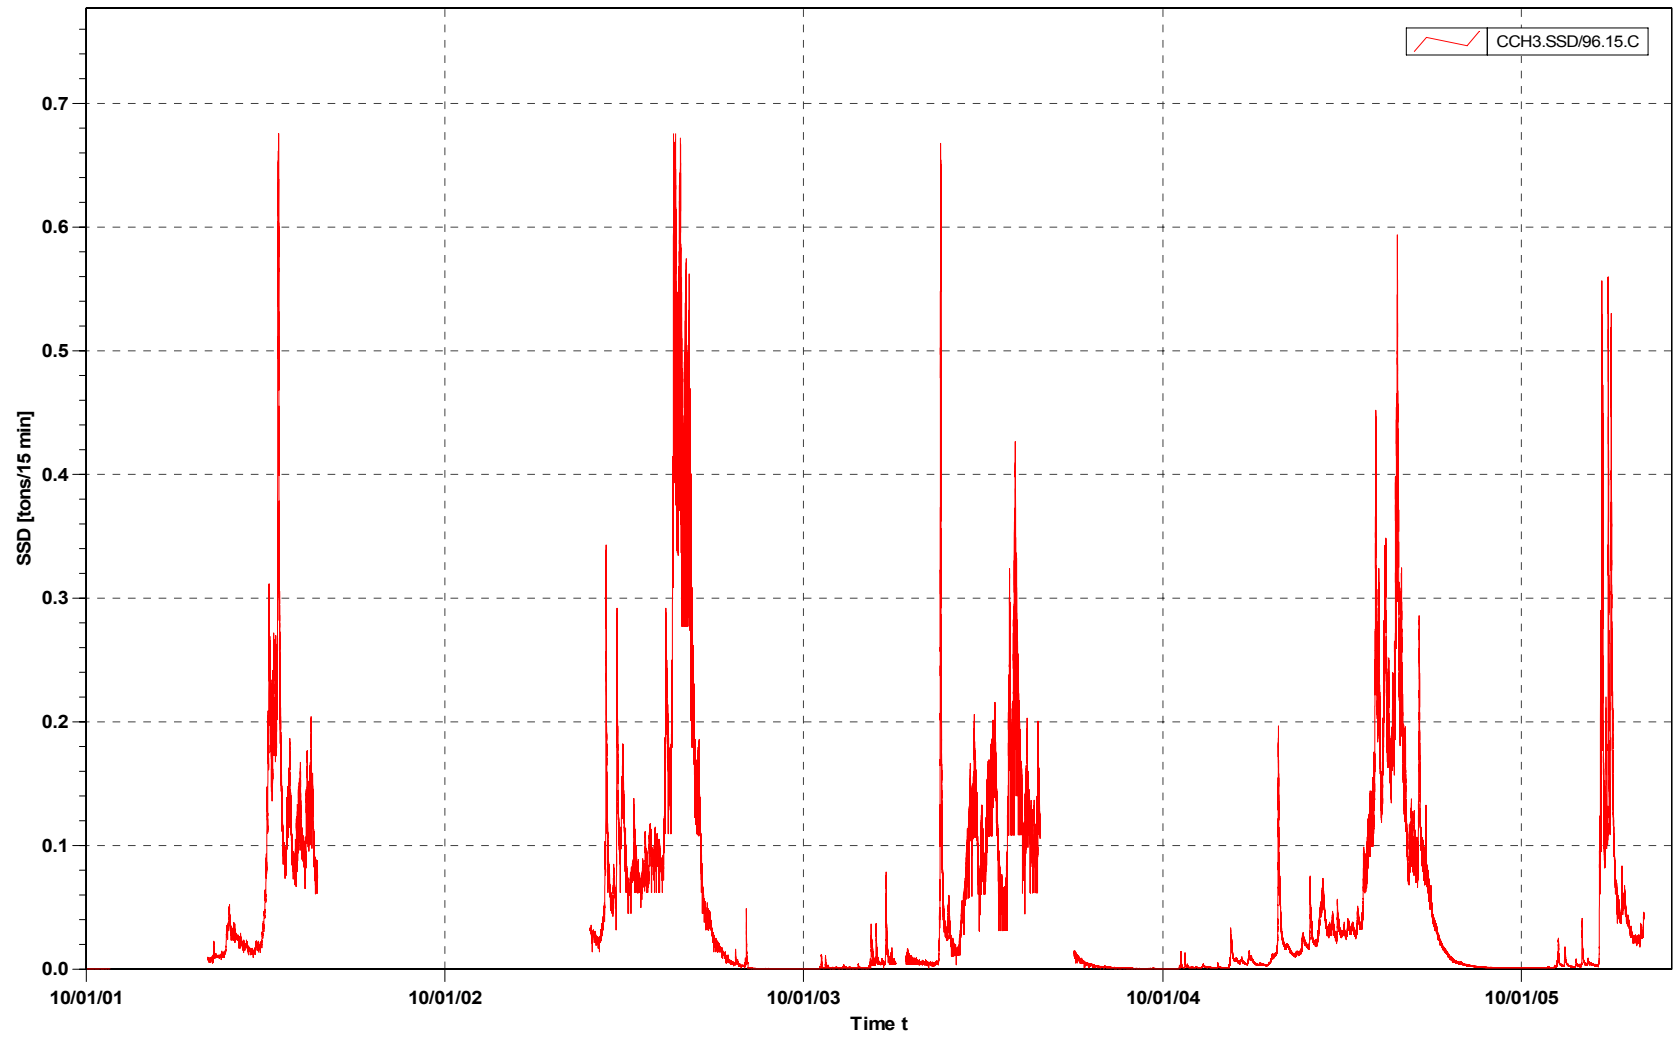
Figure 4. Coffee Creek at Highway 3 WY 2001 to 2005 suspended sediment discharge.

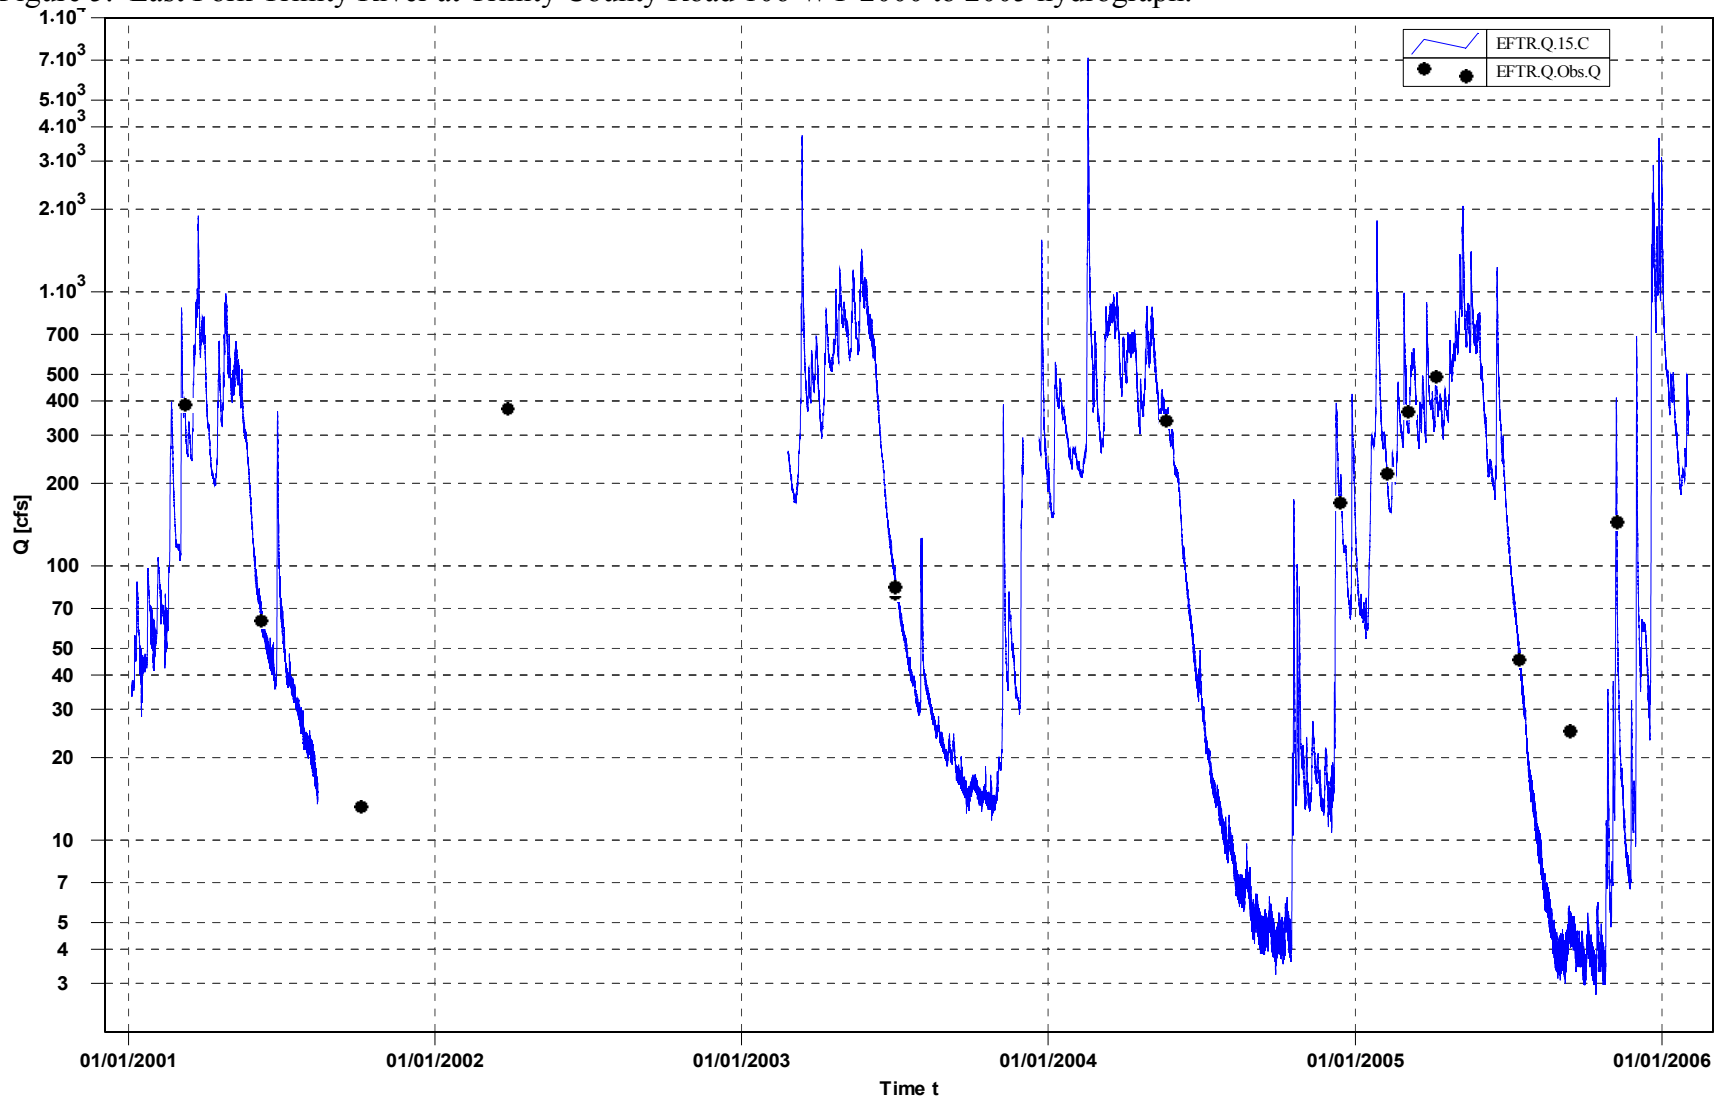
Figure 5. East Fork Trinity River at Trinity County Road 106 WY 2000 to 2005 hydrograph.

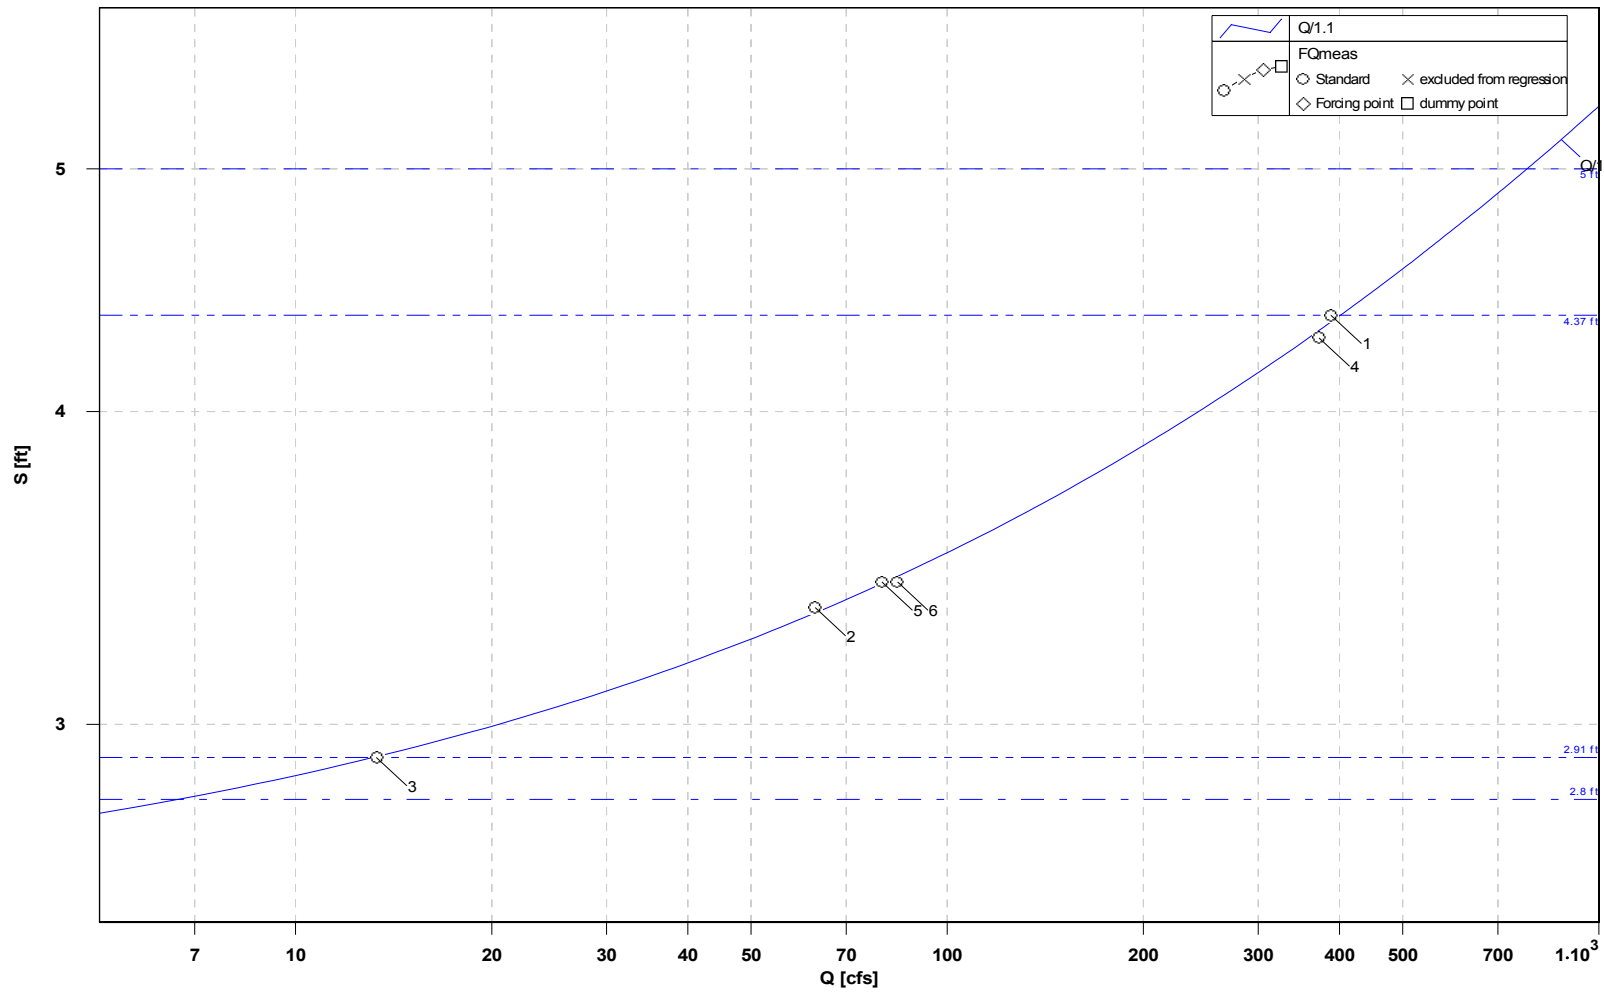
Figure 6. East Fork Trinity River at Trinity County Road 106 streamflow rating curve.

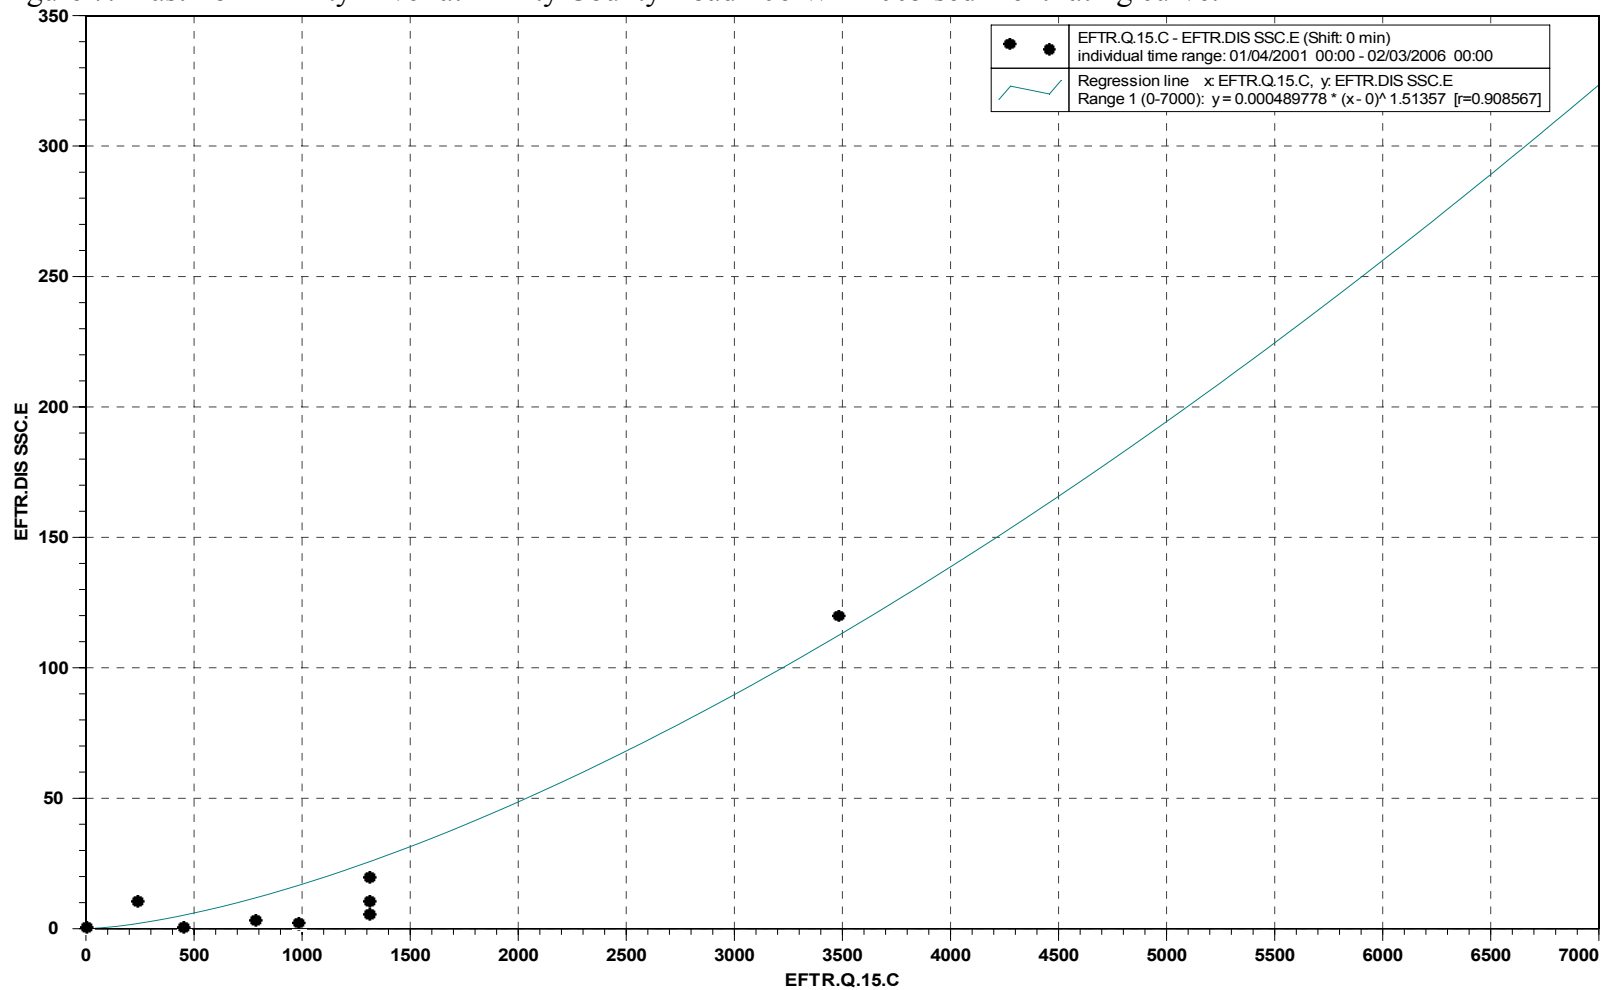
Figure 7. East Fork Trinity River at Trinity County Road 106 WY 2005 sediment rating curve.

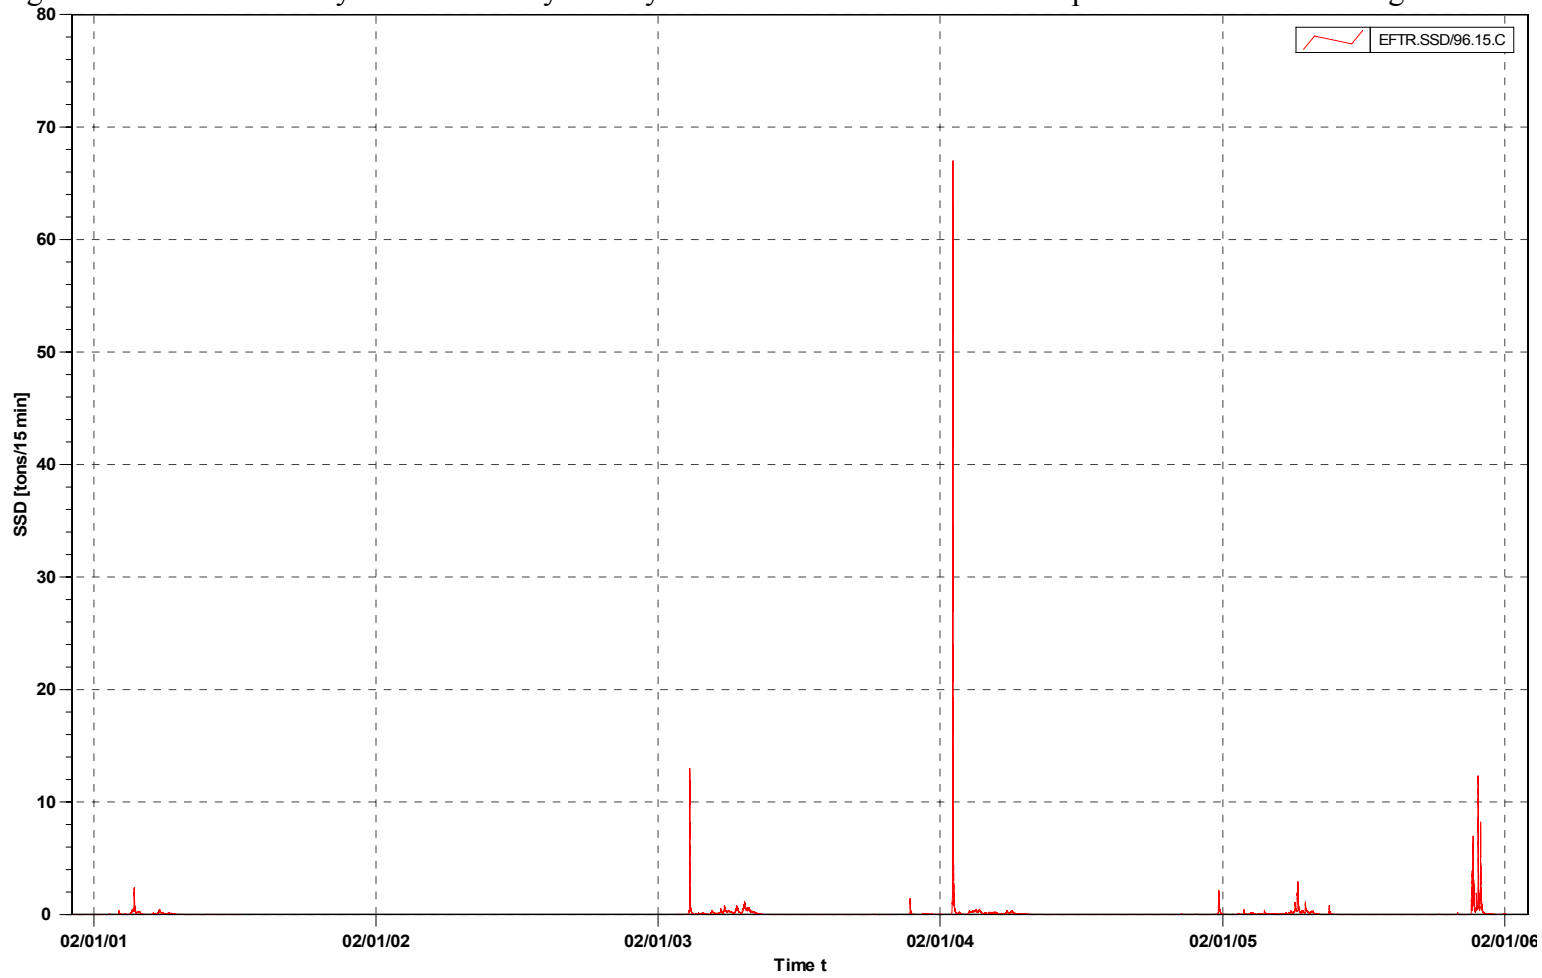
Figure 8. East Fork Trinity River at Trinity County Road 106 WY2000 to 2005 suspended sediment discharge.

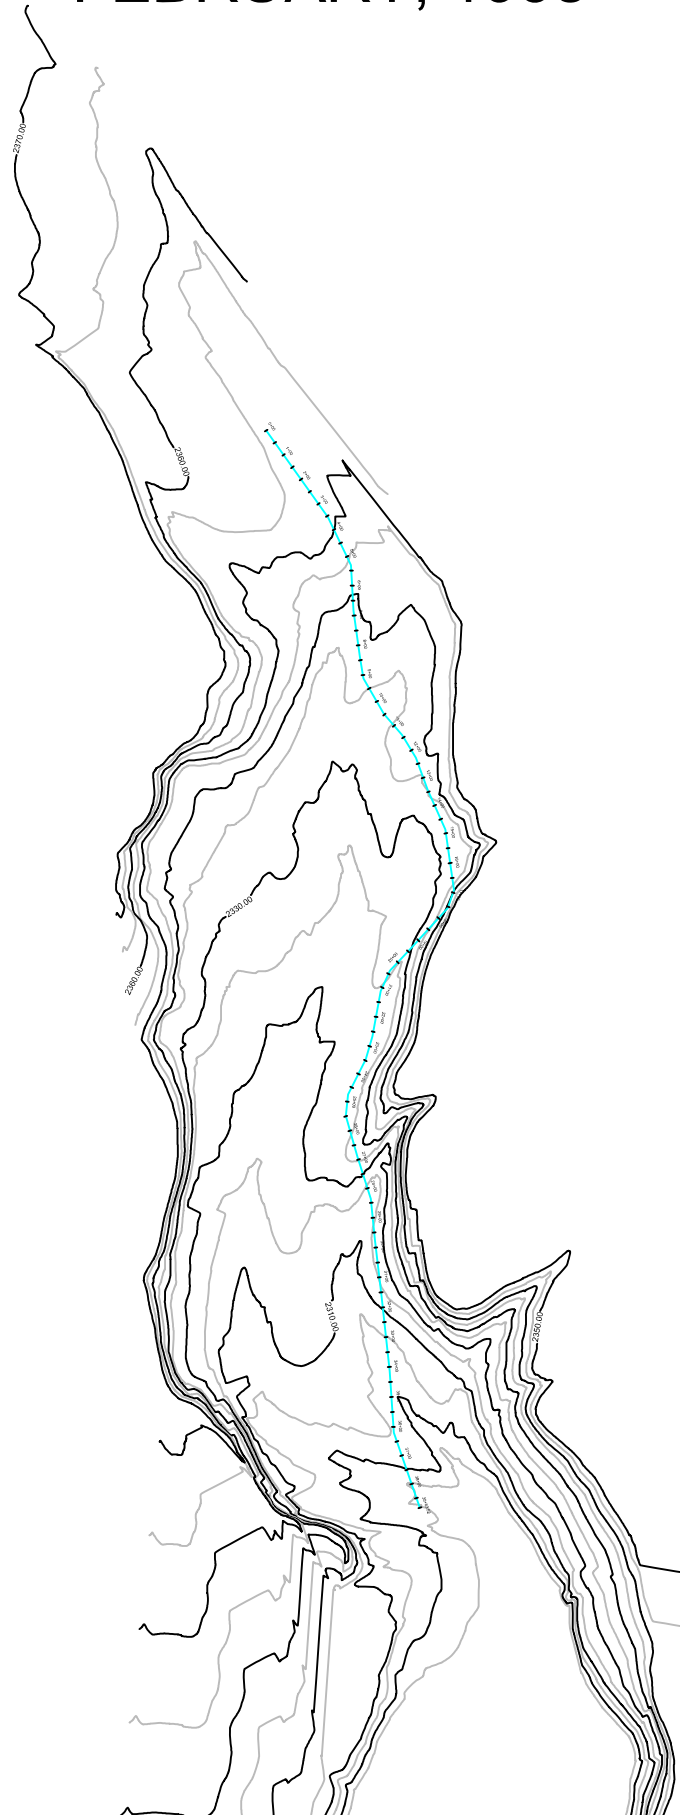
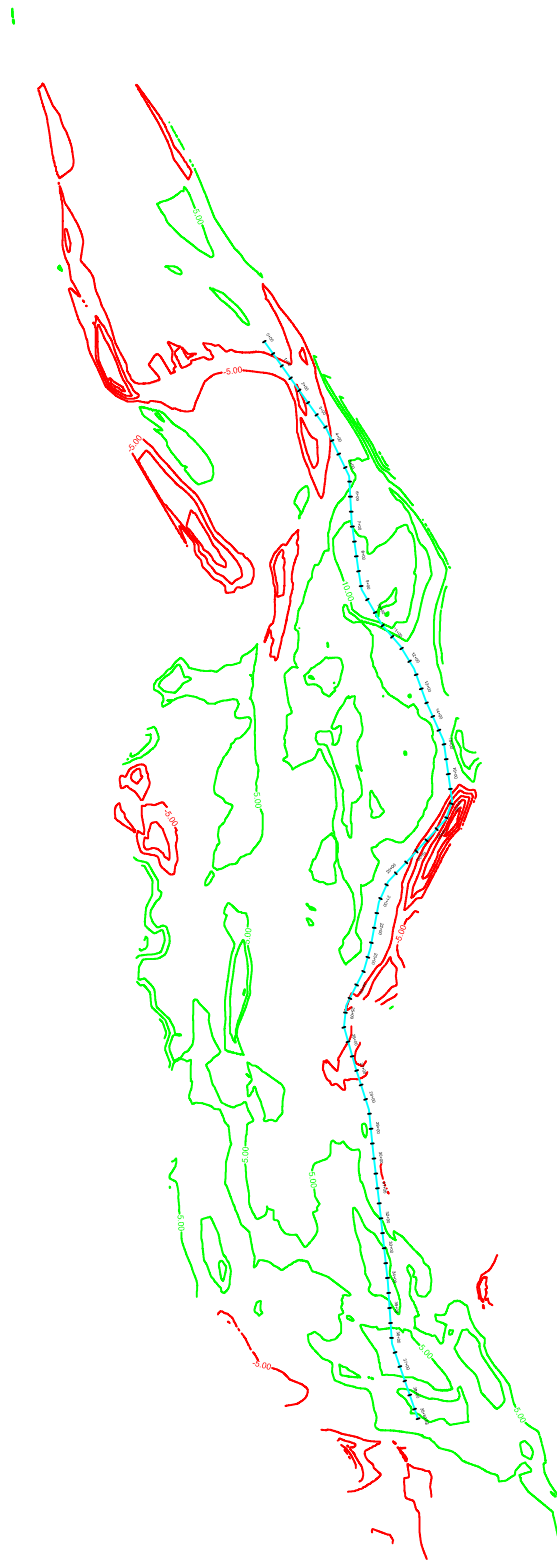
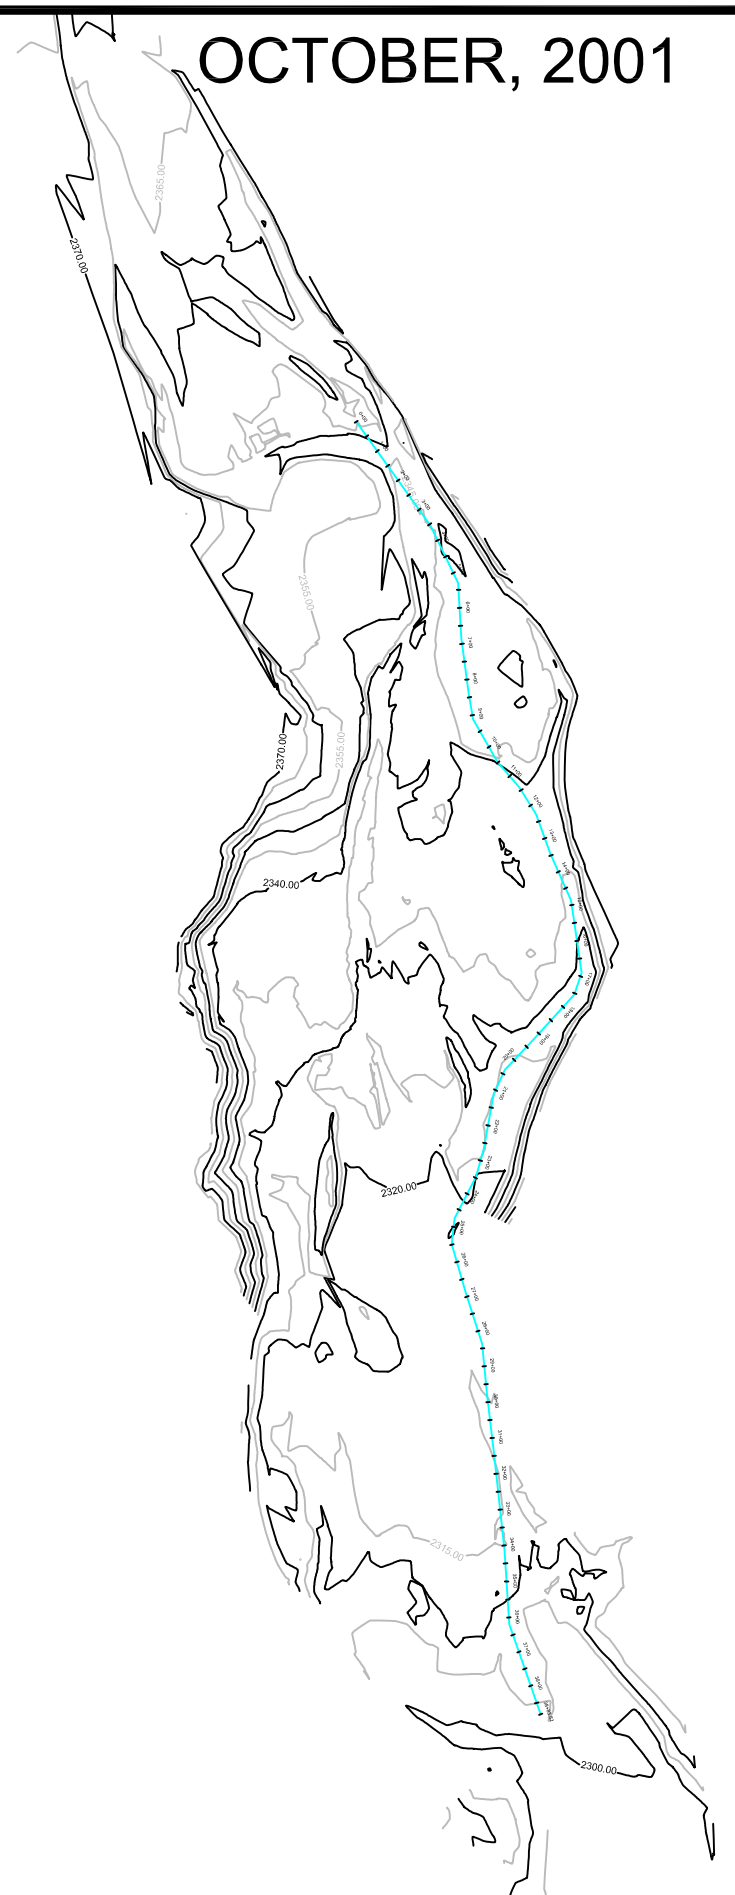
ISOPACH

STUARTS FORK DELTA VOLUMES

212700 CY CUT 468600 CY FILL 255900 CY NET FILL
