Upper Trinity River Sediment Source Analysis

Prepared for:
Trinity County Resource Conservation District
P.O. Box 1450
Weaverville, CA 96093

Prepared by:
James Fitzgerald, PG (#8082)
Graham Matthews and Associates
P.O. Box 1516
Weaverville, CA 96093
February 2006

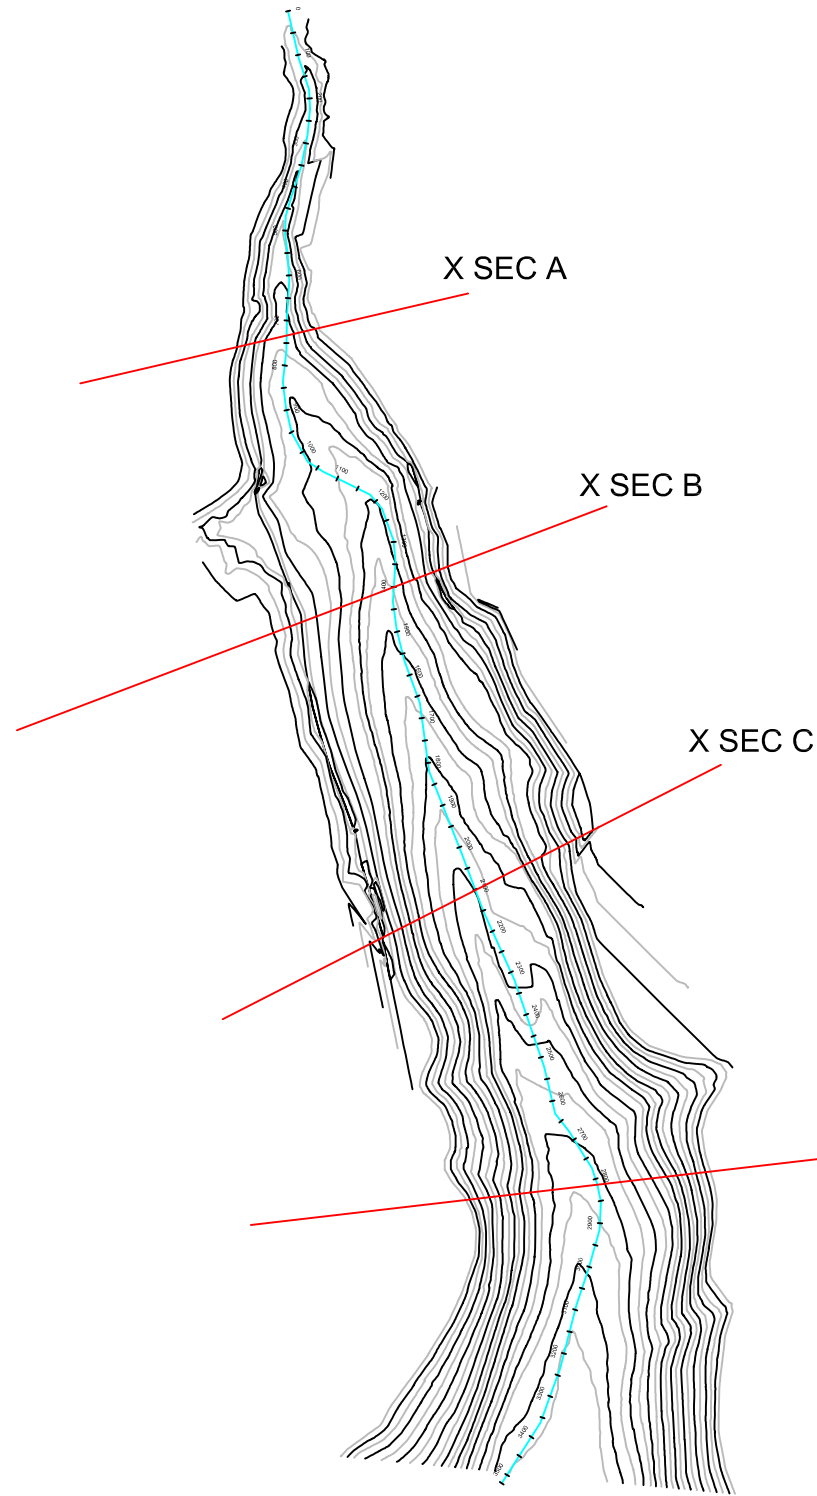
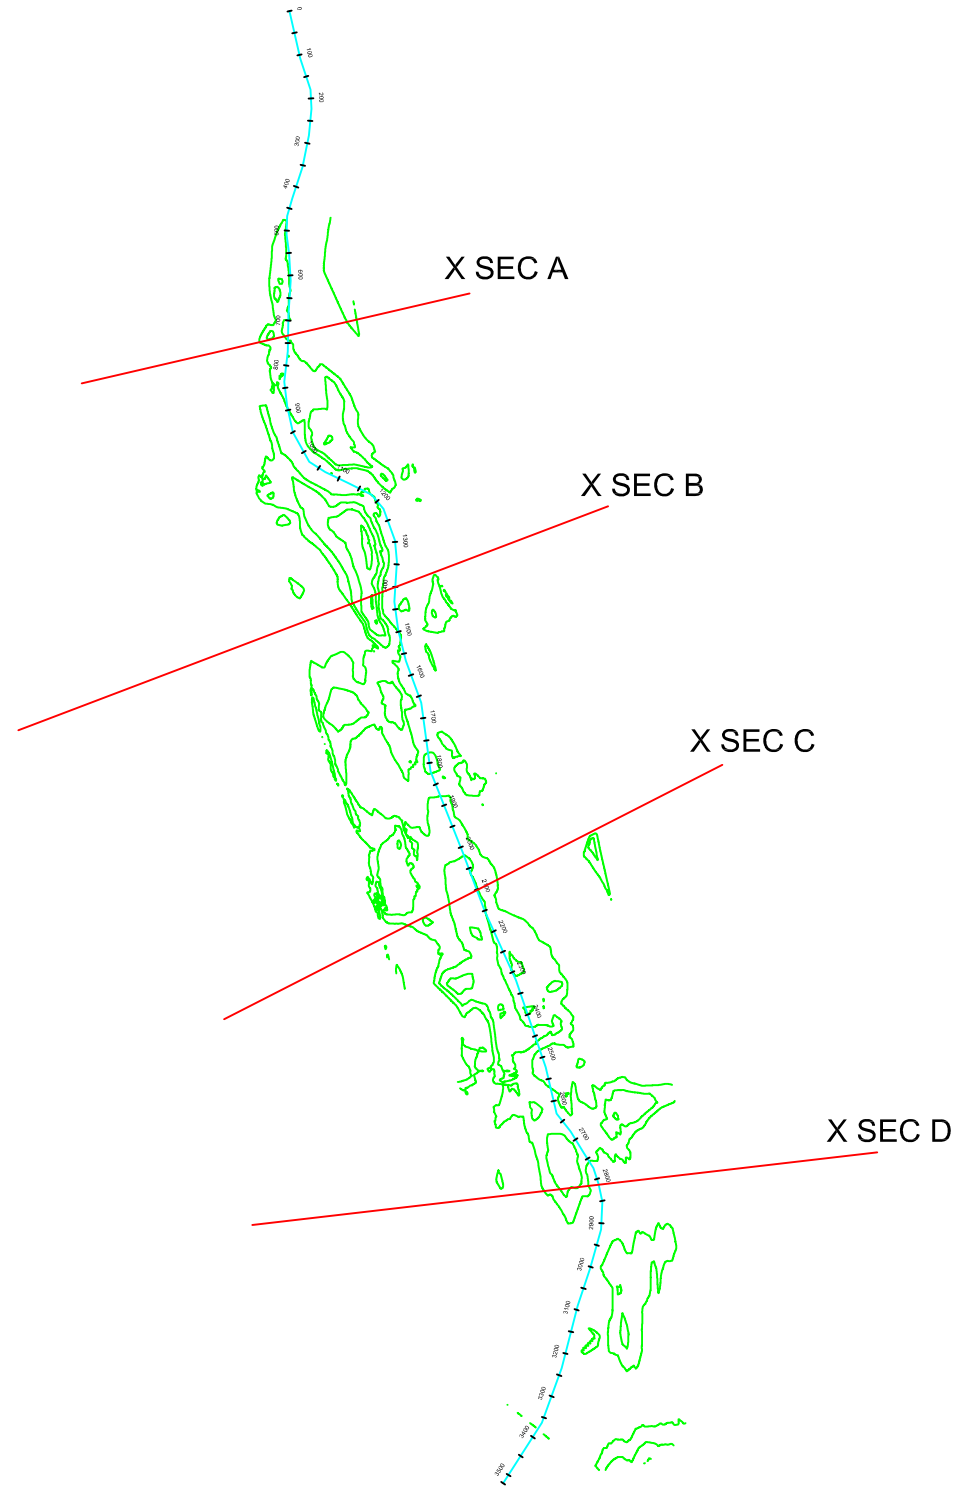
ISOPACH

MULE CREEK DELTA VOLUMES

168500 CY FILL

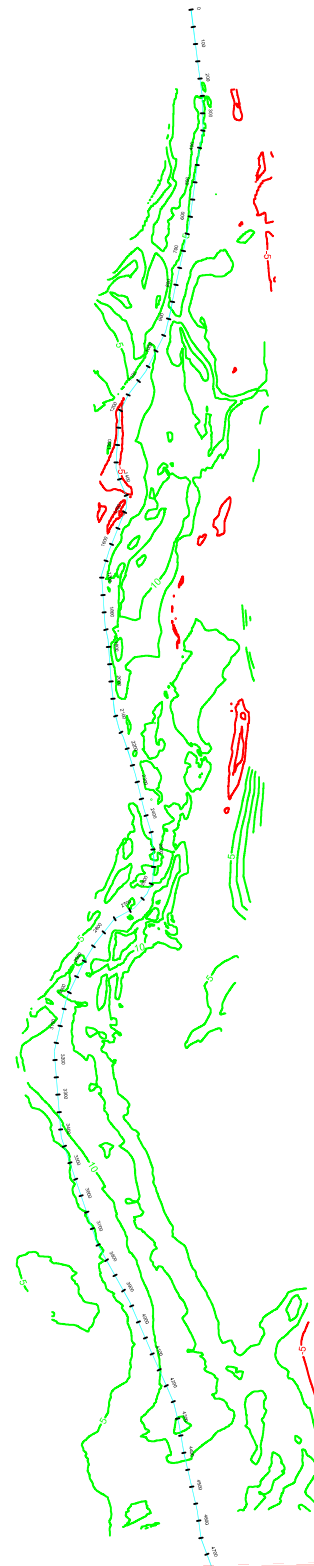
ISOPACH

EAST FORK STUART FORK DELTA VOLUMES

24300 CY CUT 409400 CY FILL 385100 CY NET FILL
